## **DAMAGE ANALYSIS OF INSULATED PIPES USING DIGITAL DETECTOR ARRAY DAN COMPUTED RADIOGRAPHY**

**Abstract:** The provision of insulation on the pipe functions to prevent heat transfer, but the provision of this insulation causes the pipe to be susceptible to damage due to oxidation. In this study, an analysis of damage to insulated pipes will be carried out using a Digital Detector Array (DDA), Computed Radiography (CR), and XRF. Based on the test results, it is known that the image quality using DDA with a voltage of 240 kV produces the most optimal contrast resolution. The results of the thickness dimension measurement using the DDA method on insulated pipes are 3.38 mm, and on insulated pipes with artificial defects are 4 mm. Compared with the CR method, the values are 3.02 mm and 3.94 mm, respectively. The smaller the difference, the more accurate. From the calculation of the ISee software, it is also known that the DDA method can detect a greater number of defects, namely 24, compared to the CR method, which has only 14. The results of the XRF test show that the insulated pipe includes low-carbon steel with a carbon content of 0.057% and 94% ferrum. This high ferrous content

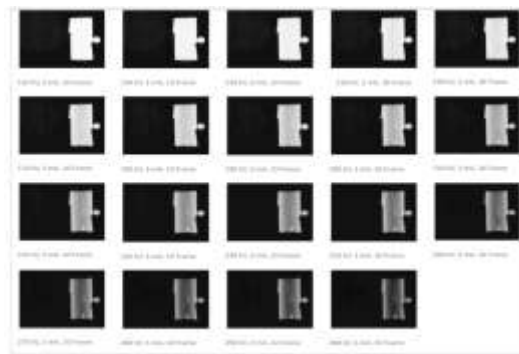
**Figure 2.** Voltage Optimization for Grey Value, SNR, and SNRN Using DDA

The image above is a digital radiographic image using DDA with voltage variations of 120kV, 130kV, 140kV, 150kV, 160kV, 170kV, 180kV, 190kV, 200kV, 210kV, 220kV, 230kV, 240kV, 250kV, 260kV, 270kV, 280kV, 290kV, 300kV. It uses a current of 3 mA and 10 frames. Grey Value is the numerical value of the pixels of a digital image used to determine the grayness level of the pixels in the image. The impact of the gray value on the image determines the gray value of each image and produces a linearity graph that shows the relationship between grayness and voltage levels [8]. In particular, the gray value that meets the standard is 50% to 90% of 65,536 or  $2^{16}$  bites [6]. The optimal gray value is at voltages of 240 kV, 250 kV, 260 kV, 270 kV, 280 kV, 290 kV, and 300 kV in Figure 3. The higher the kV, the more energy the X-rays have. This can increase the penetration ability of X-rays so that if the KV is used too high, the image becomes black [9].

This study needs good image quality to detect artificial defects in pipes. The digital data of the radiographic detector should be evaluated with a linearized gray-value representation, which is directly proportional to the radiation dose for the determination of SNR, SRb, and SNRN. For optimal image display, contrast and brightness should be set interactively. Optional filter functions, profile plots, SNR, and SNRN tools should be integrated into the software for image display and evaluation [6]. In this Test, it is necessary to search for kV optimization to find the appropriate gray value, SNR, and SNRN. The results of the image can be seen in Figure 2.

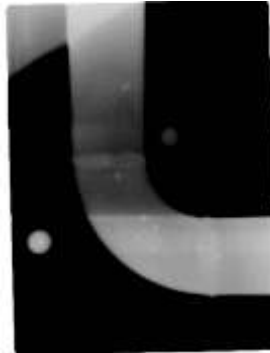
**Figure 7.** Insulated Pipe Using 180kV, 3mA, and 40 Second Computed Radiography

In Figure 7, to obtain image quality on insulated pipes using computed radiography. Using 180kV, 3mA, and 40 seconds produces 50932 gray values, 209 SNR, and 73 SNRN. The SRB value obtained was 0.25, and the duplex value obtained was D6. There is a bad pixel on the IP, this can happen due to repeated use. Although there are bad pixels, they do not affect the interpretation. It is better to update the IP to minimize the occurrence of repeated shooting [12].
